**MEMO**

Date:  
September 15, 2009

Subject:  
Plainwell Bank Maintenance/Repair and Approach for Erosion at Removal Areas 8 and 9B

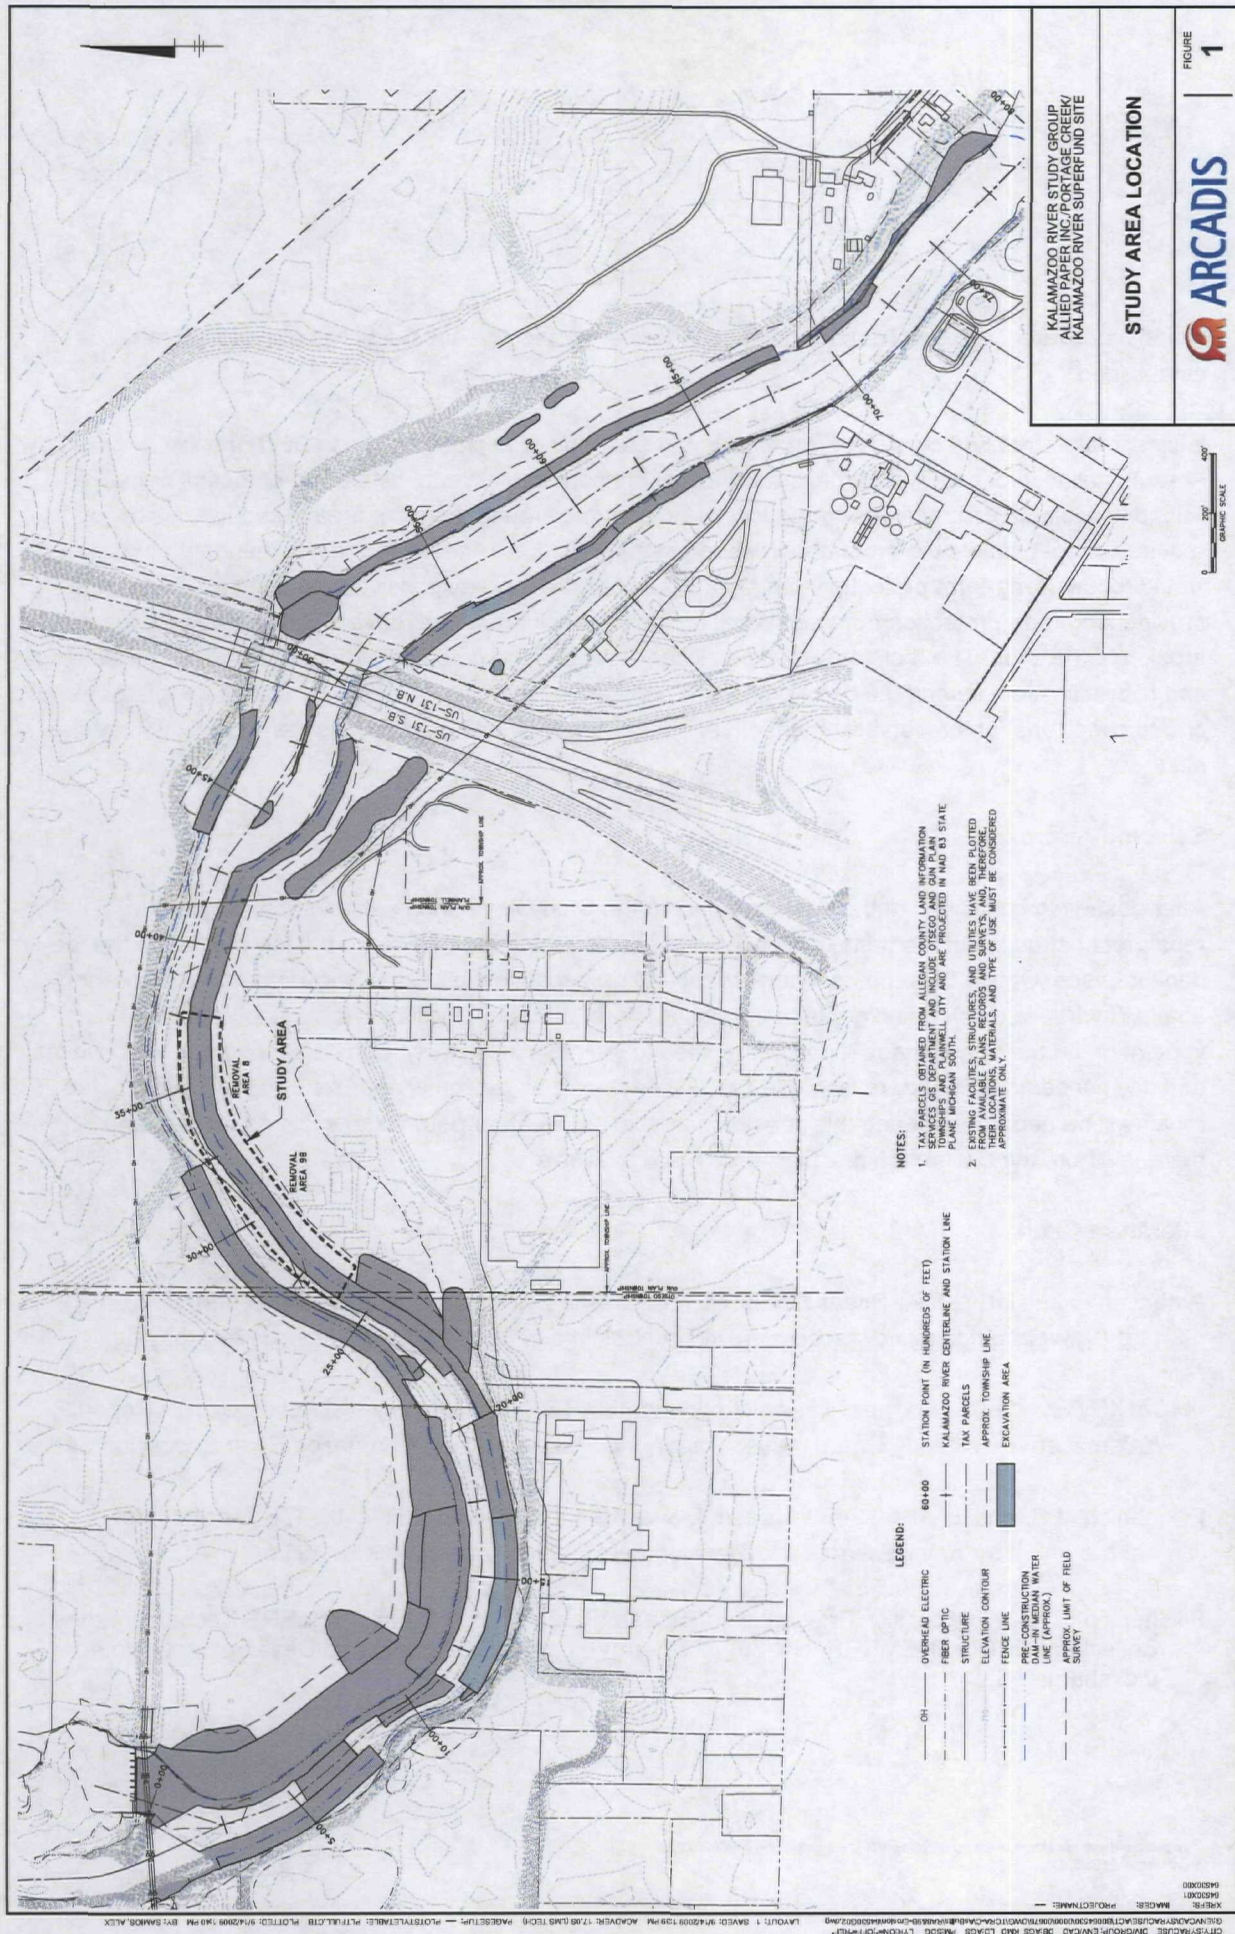
During the bank inspection event, approximately 1,000 feet (ft) of bank in Removal Areas 8 and 9B (the Study Area; Figure 1) was observed to be showing significant signs of erosion. The Study Area is located along the inside bend of a large gradual meander that was anticipated to be a depositional area following removal and revegetation activities and not subject to erosional forces requiring rock-based armoring. Figures 2 and 3 present the velocity and shear stress predicted by the RMA2 model for post-construction conditions in the Study Area during a 2-year storm event, as presented in the TCRA Design Report (ARCADIS BBL 2007). As shown, the near-bank shear stress and velocity were calculated to be 100 to 150 dynes per square centimeter ( $\text{dynes/cm}^2$ ) and 2 to 4 feet per second (ft/s), respectively. Vegetated banks are capable of withstanding shear stresses of 1,500  $\text{dynes/cm}^2$  (American Excelsior 2009) and velocities of up to 7 ft/s (Fischenich 2001). Based on the modeled shear stress and water velocity, the

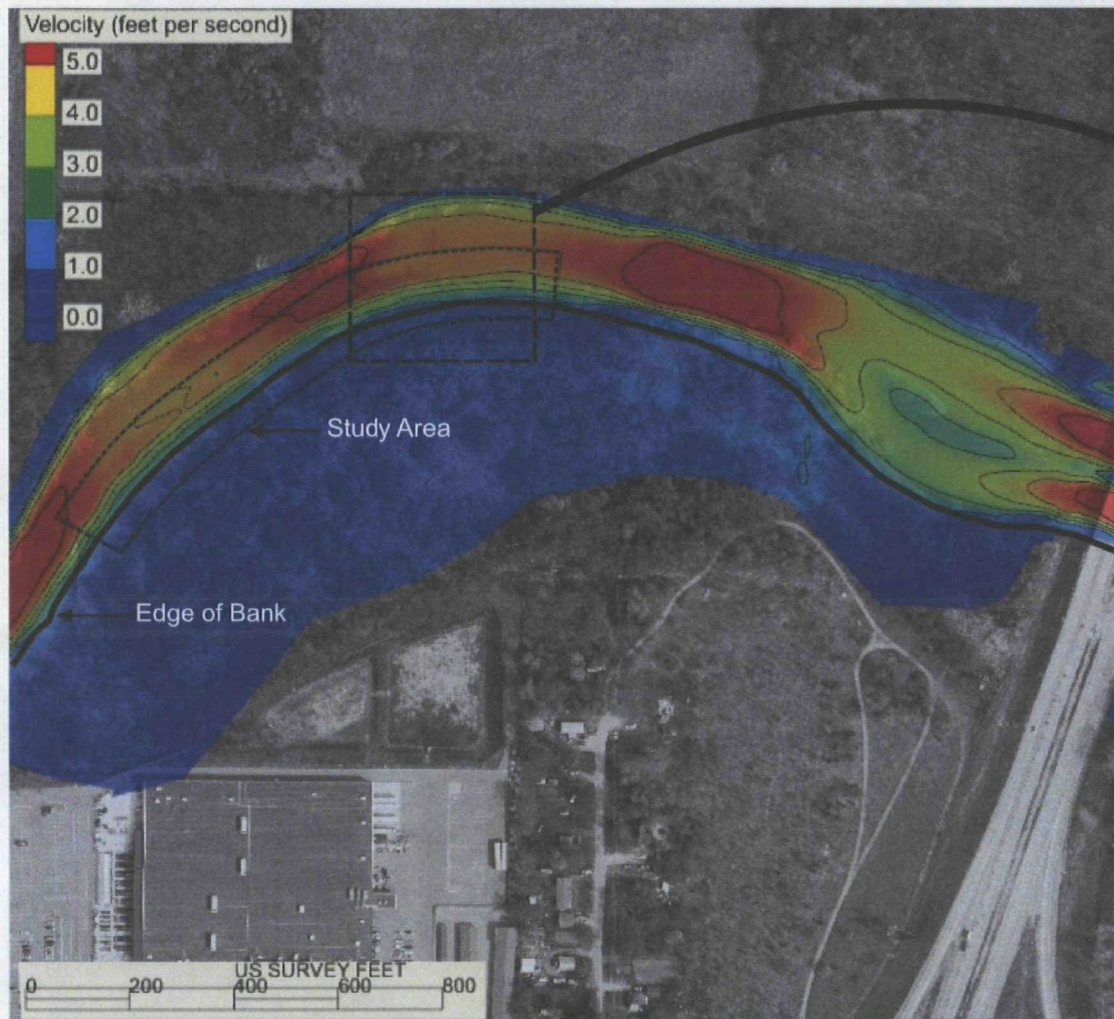
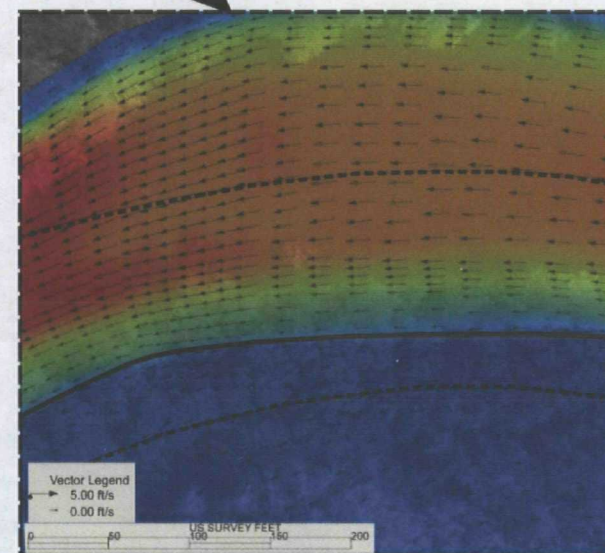
FIGURE  
**2**

Figures 2 and 3 show that the bank in the Study Area is exposed to a water velocity of 2 to 4 ft/s and shear stress of 100 to 150 dynes/cm<sup>2</sup> under post-construction conditions at the bankfull discharge. Model outputs with the rock vanes in place show that near-bank water velocity would be reduced to 0 to 1 ft/s and shear stress reduced to 0 to 50 dynes/cm<sup>2</sup> (Figures 4 and 5). The velocity and shear stress reductions are further illustrated with RMA2 model output in Figures 6 and 7.
